**KPMG AZSA LLC**

**Case Study:**

**Bad Practices of Electric Power**

**Infrastructure Investment / Development**

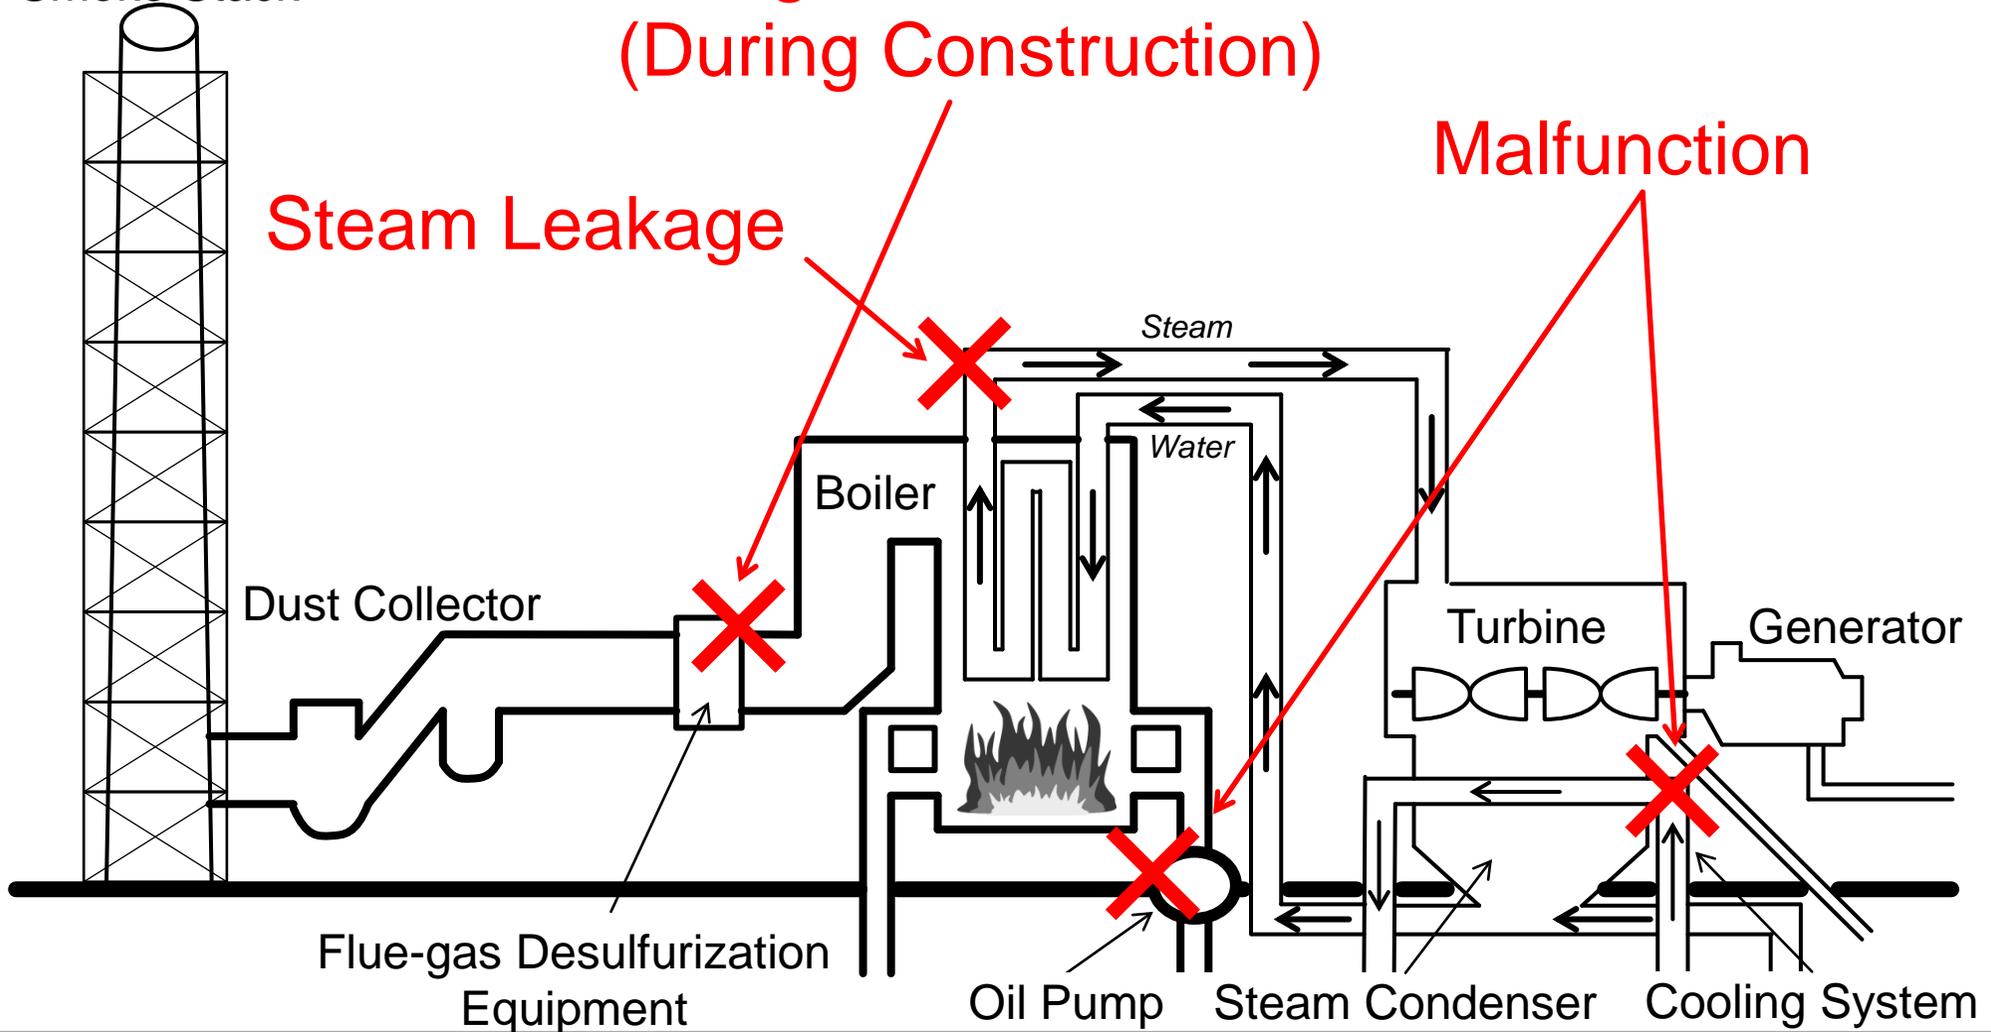
# Case Study 1: Overview of the Problem (1)

Centralized  
Smoke Stack

A Large Scale Fire  
(During Construction)

Steam Leakage

Malfunction

- ◆ In October 20vv, the flue-gas desulfurization equipment in Unit 1, which was under construction, caught fire from the sparks of welding, leading to a large scale fire. As a result, the construction schedule of Unit 1 was delayed.
- ◆ In 20zz after the operation started, blackouts frequently occurred due to malfunction. The problem was caused by faults in various points such as the relay system of the oil pump motor and the cooling system and steam leakage in the boiler.
- ◆ Steam leakage occurred in December 20ww, but the equipment to identify the location of the fault was not available in Country B, due to its unique feature. Therefore, Company A was required to import this equipment from a foreign country, which took one month. As a result, Company A was forced to halt operation in the long term, leading to significant economic loss.

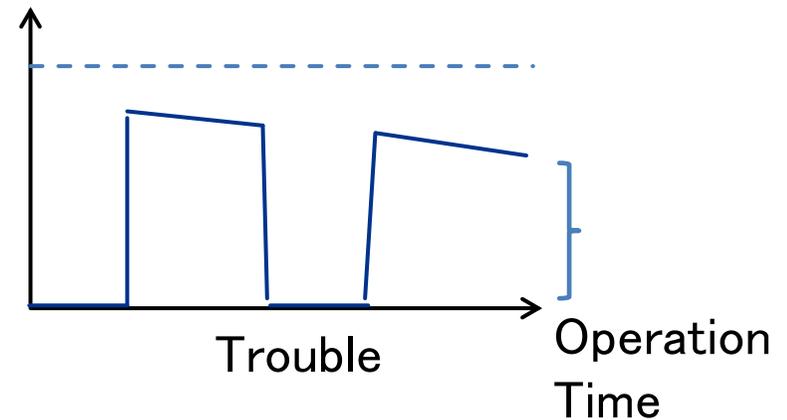
### Case 1 (Capacity)

- ◆ Delay in construction schedule
- ◆ Low operation rate
- ◆ Required significant time to recover from stoppage of operation

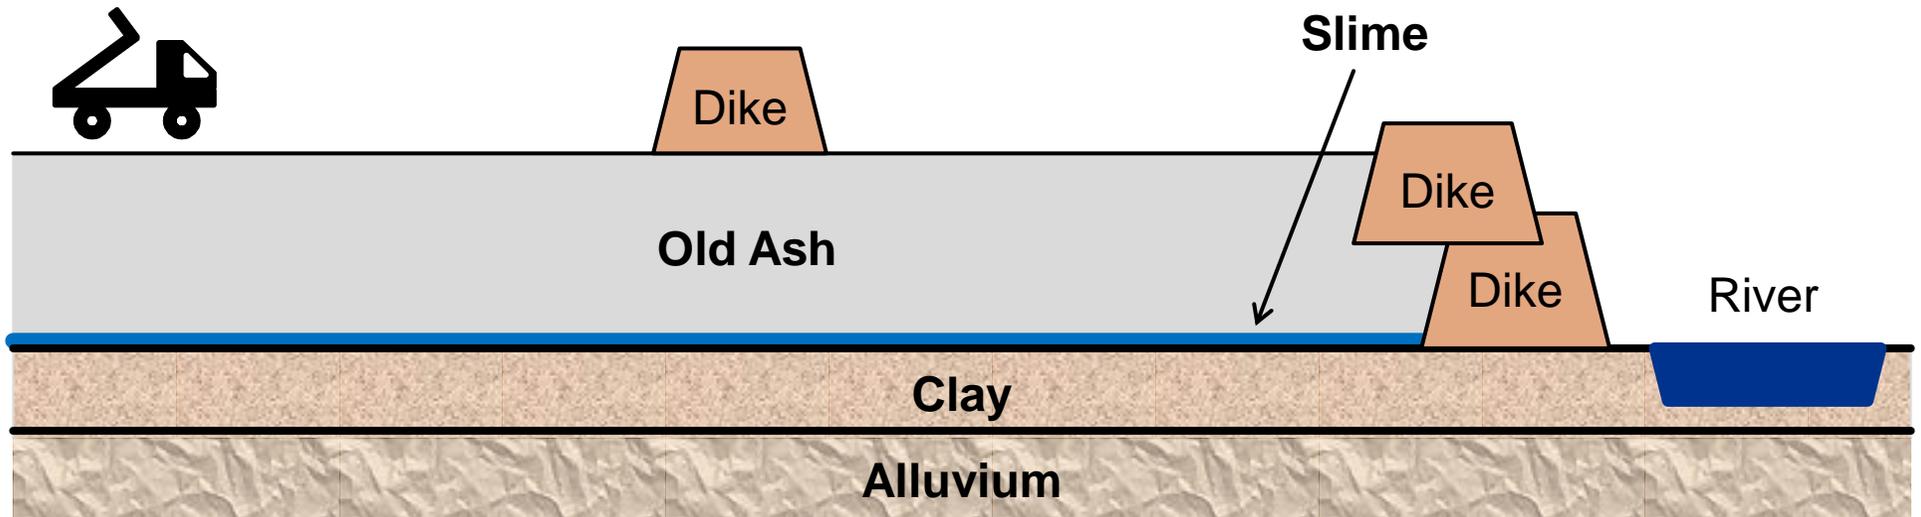
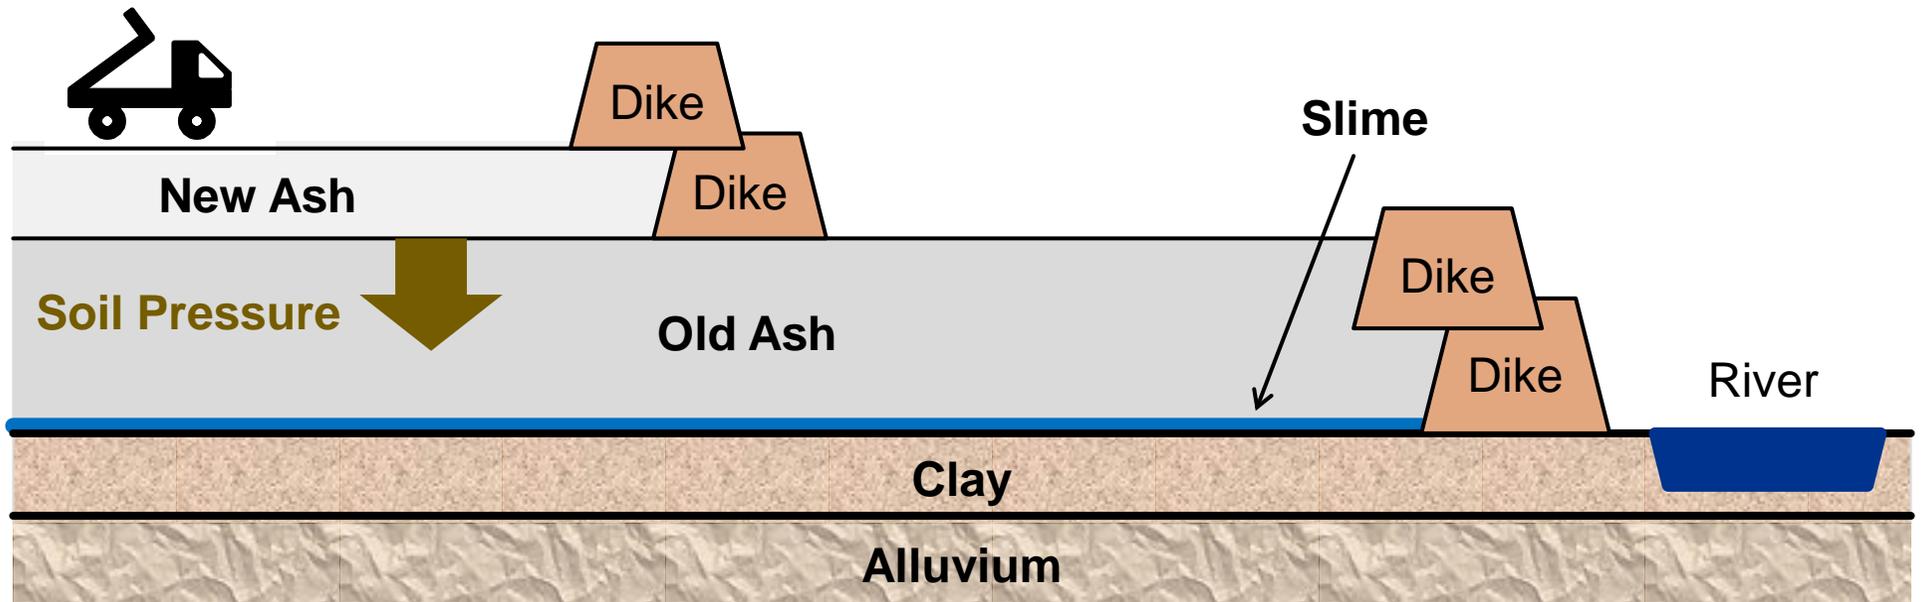
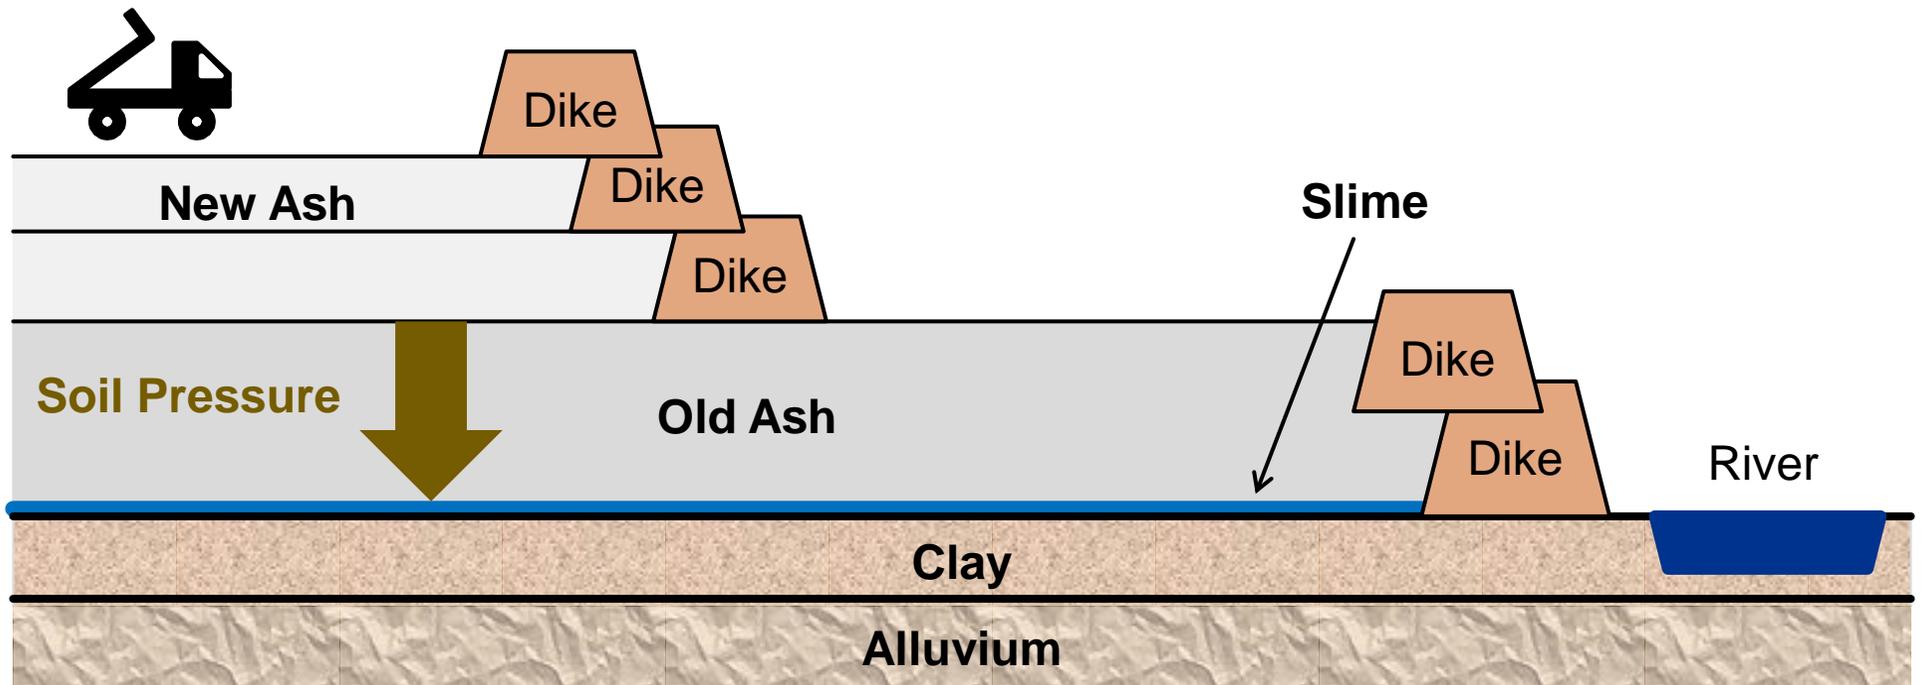
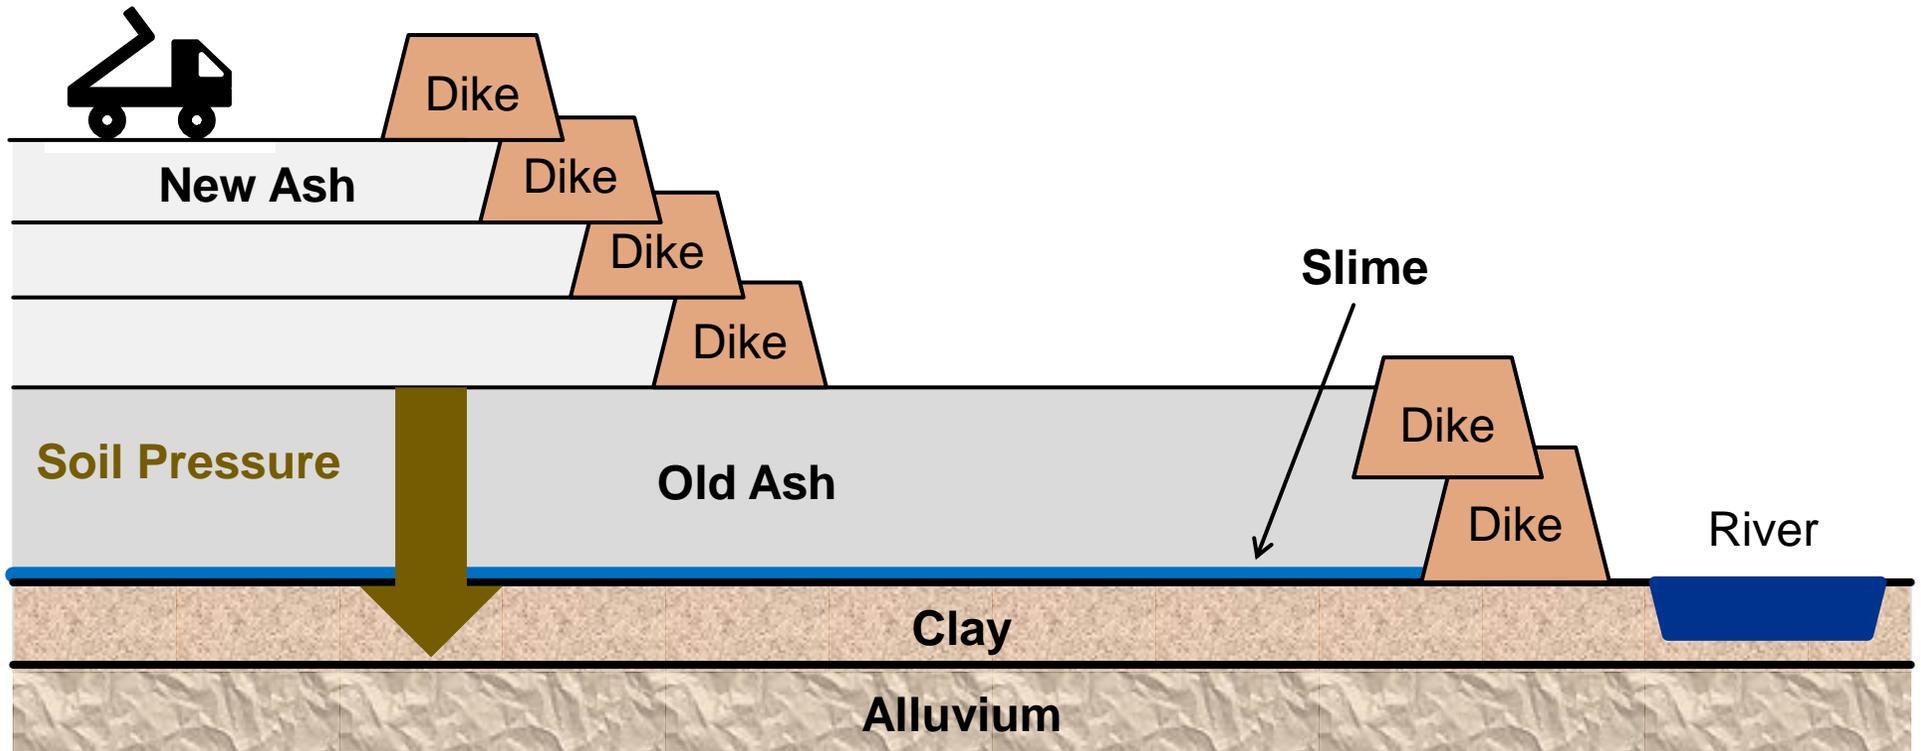
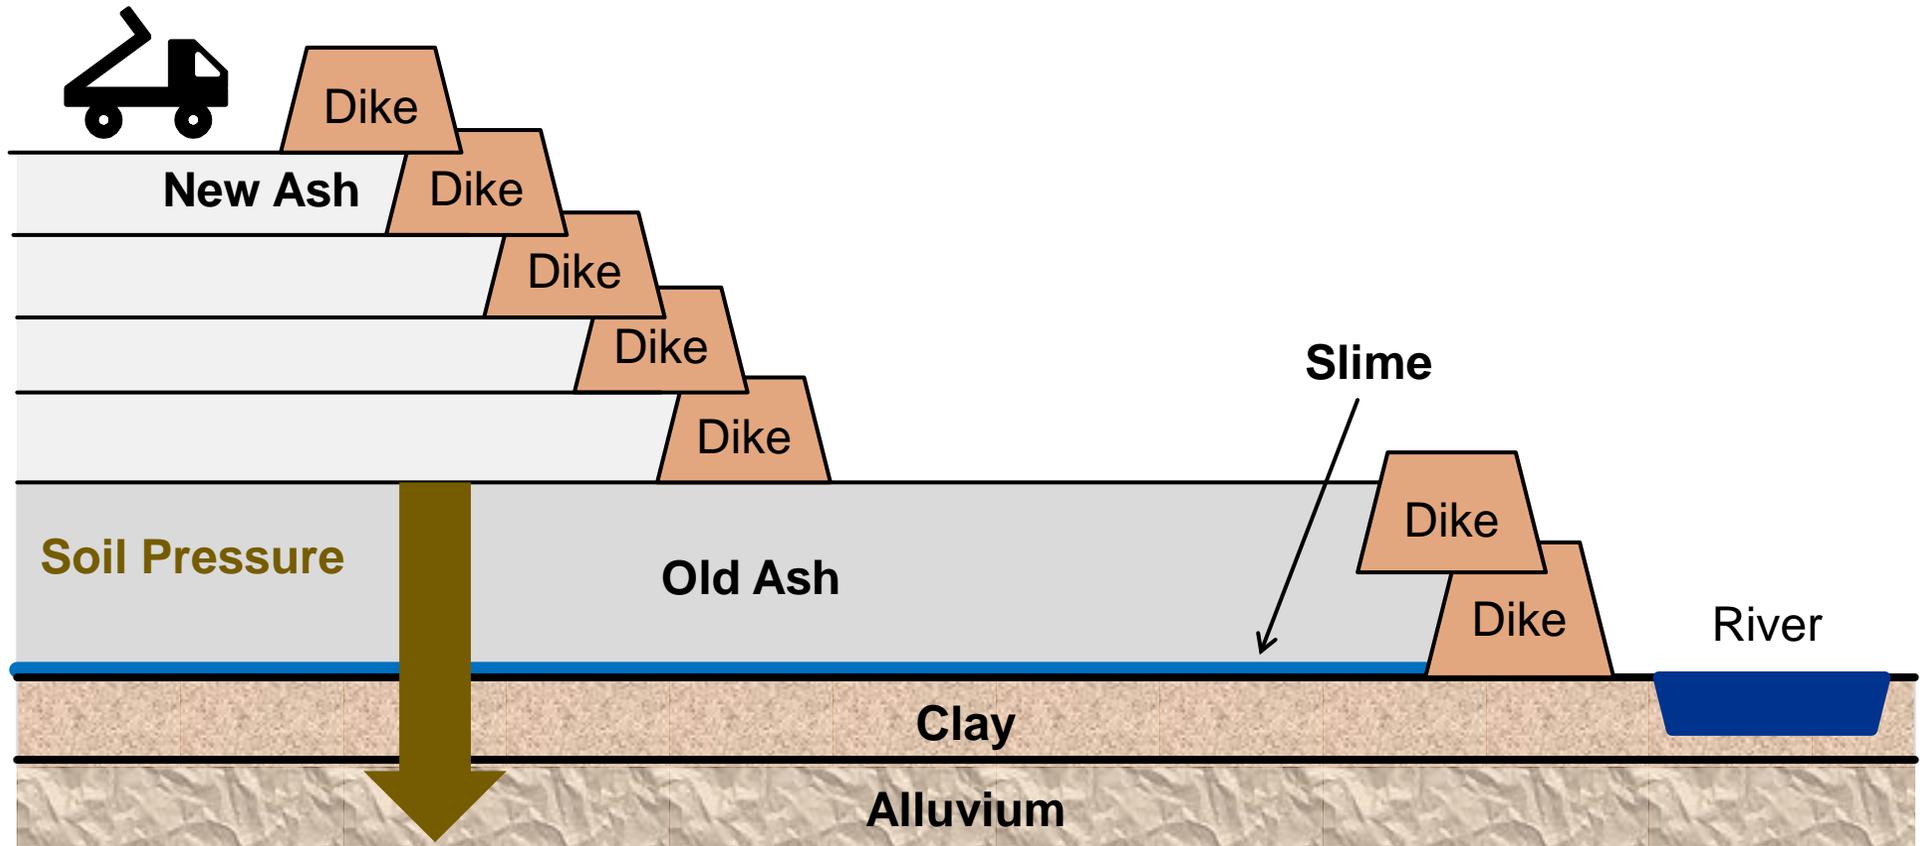
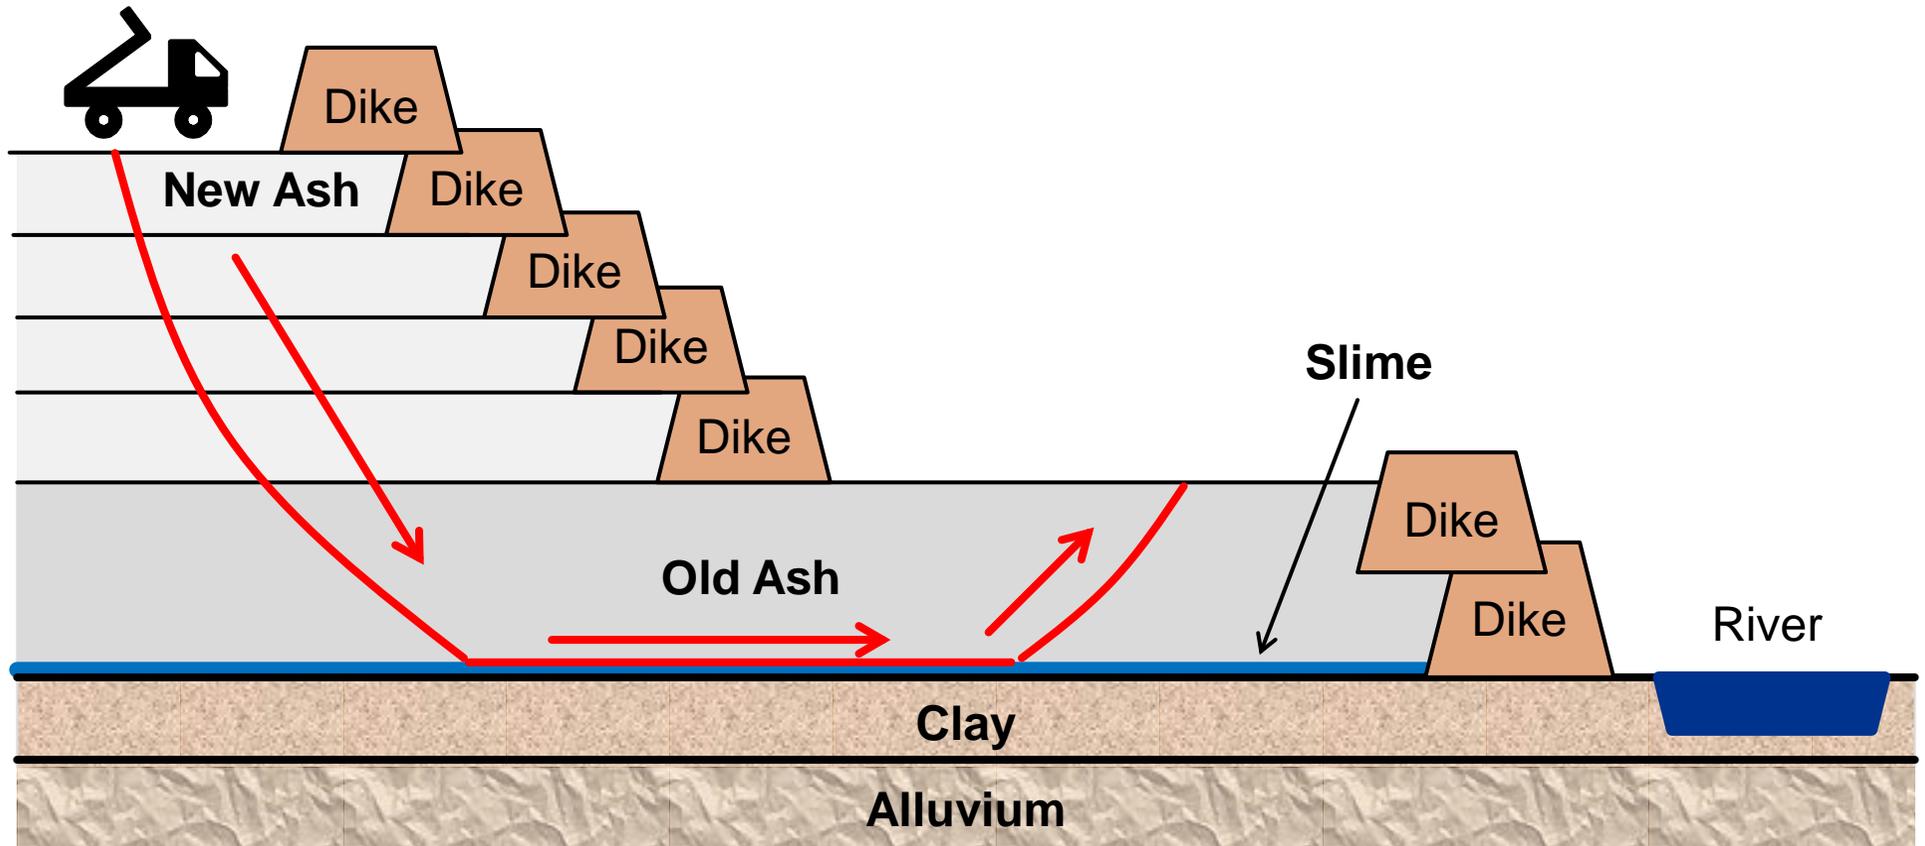
- ◆ In 20xx, a large scale land slide occurred in the new ash pond constructed by Company E and 4.12 million kl of coal ashes leaked as a result of the collapse of dikes.
- ◆ The damage spread over a wide area including 45 houses and gas pipe lines.
- ◆ In addition, the leaked coal ashes flowed into the two adjacent rivers. As a result, toxic substances (i.e., arsenic, mercury, etc.) exceeding the stipulated value was detected from the rivers.
- ◆ Company E paid approximately USD1.1 billion as decontamination cost, as of 20xx.
- ◆ Furthermore, the citizens who suffered health damages are requesting Company E for compensation for such damages.

- ◆ The base of the old ash pond located below the newly established ash pond was composed of a clay stratum, and a large scale land slide occurred as a result of the pressure caused by the newly dumped coal ashes.
- ◆ The operator had identified several small scale surface slips since 20xx. In addition, an external engineering consultant had pointed out the danger of the ash pond. However, Company E did not take any immediate action against the issue.
- ◆ Company E concentrated its investment into assets directly linked to sales and profit such as generation facilities, and insufficient investments were made in other assets such as the ash pond. Company E paid little attention to environmental preservation and safety management.

- ◆ It can be assumed that the consultant that designed the new ash pond did not conduct sufficient geological survey or that there was a miscalculation in the stress computation used as an assumption of the design. Therefore, Company E could have selected a consultant with a certain level of ability as their contractor.
- ◆ Company E could have stopped dumping coal ash and taken various measures (e.g., consideration for neighboring citizens) to ensure safety of the ash pond at the time they recognized the indication of a large accident.
- ◆ Investment in environmental preservation and safety management related assets such as ash ponds could have been made, as the total cost (decontamination cost, damage compensation) exceeded the initially expected cost as a result of focusing on cost reduction.

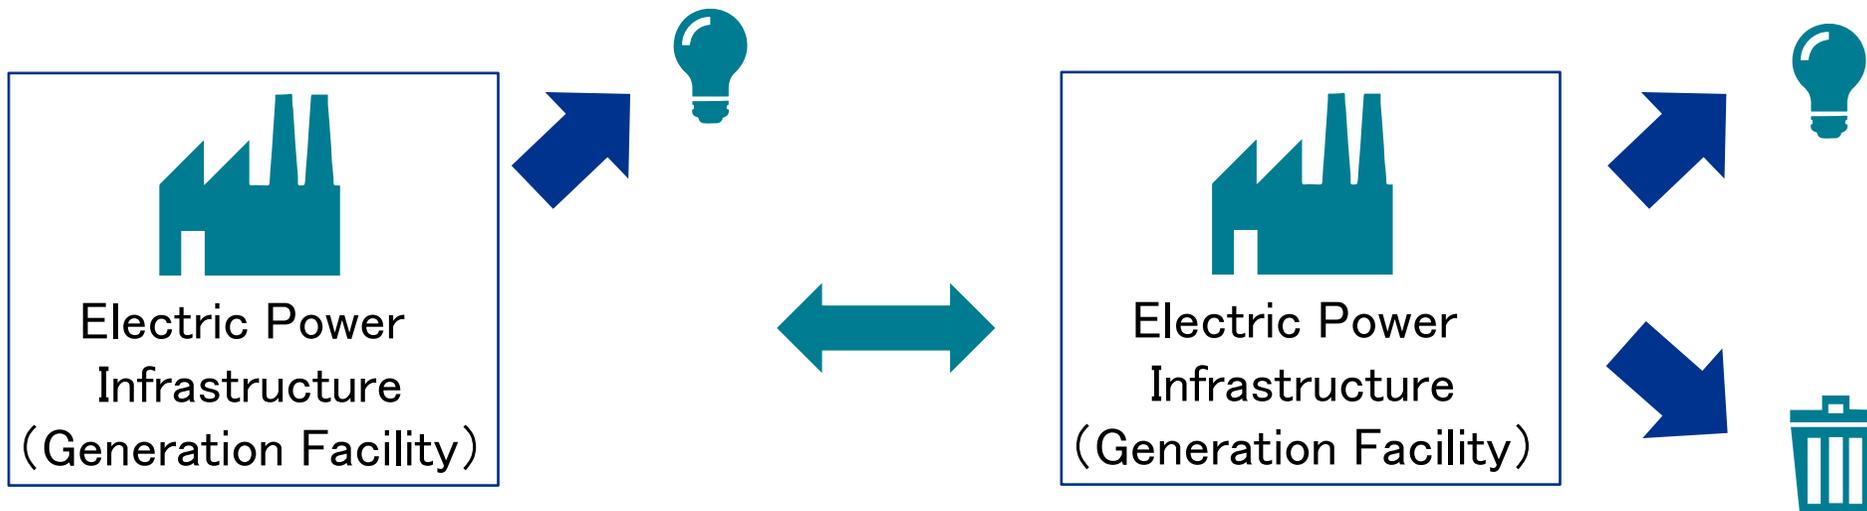
### Case 2 (Output)

- ◆ Caused environmental destruction to the neighboring areas
- ◆ Caused direct damage to road infrastructures and private properties

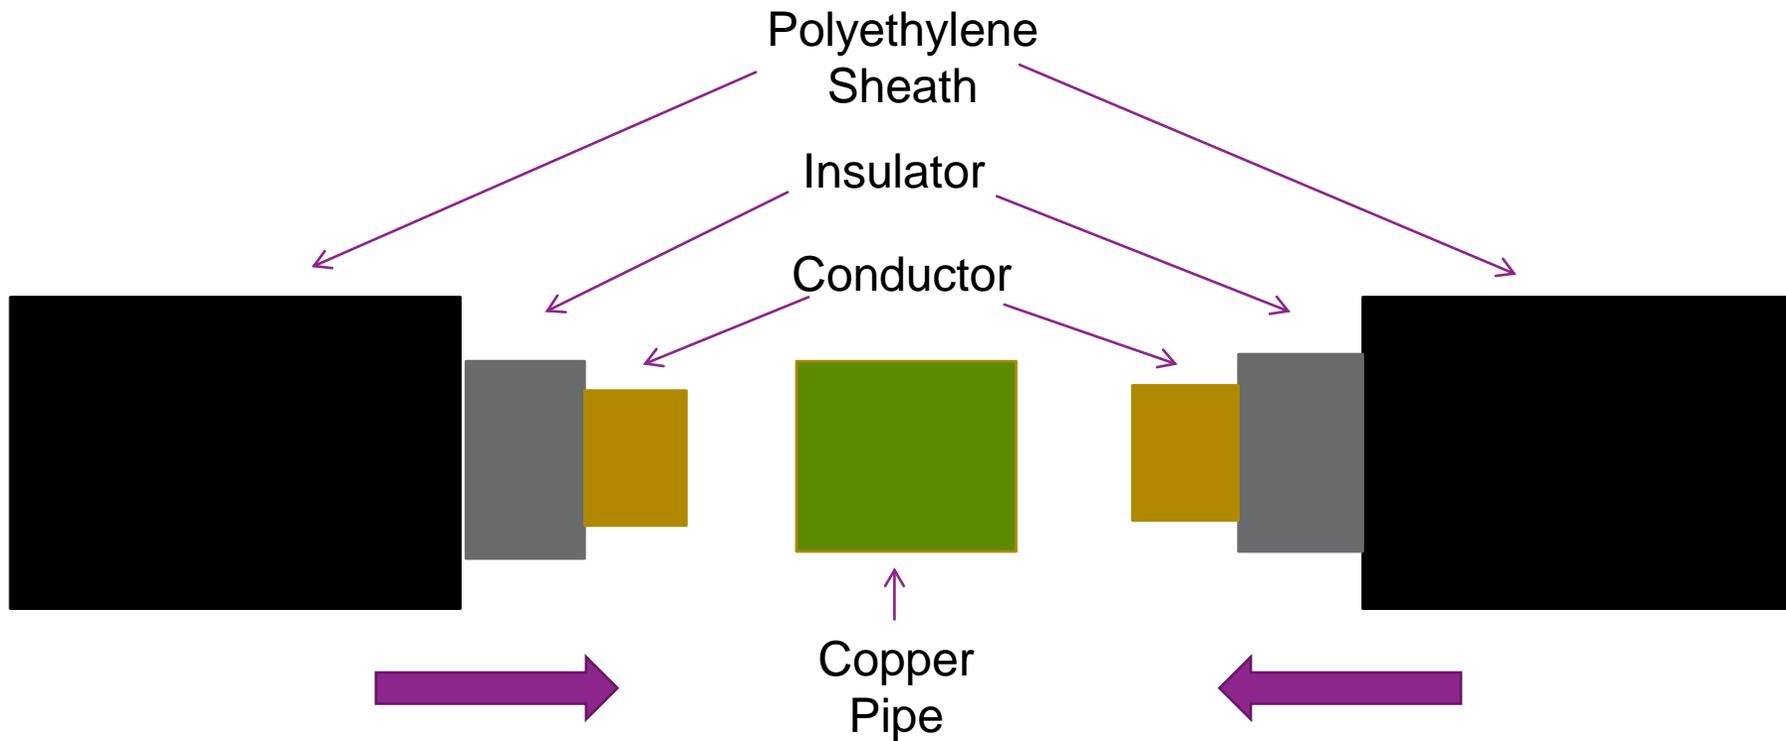
## Case Study 3: Image of a joint (1)

- ◆ A joint is a material used at a connecting point to connect two cables. An electric cable is inserted into the copper pipe from each side and swaged by squashing the copper pipe.

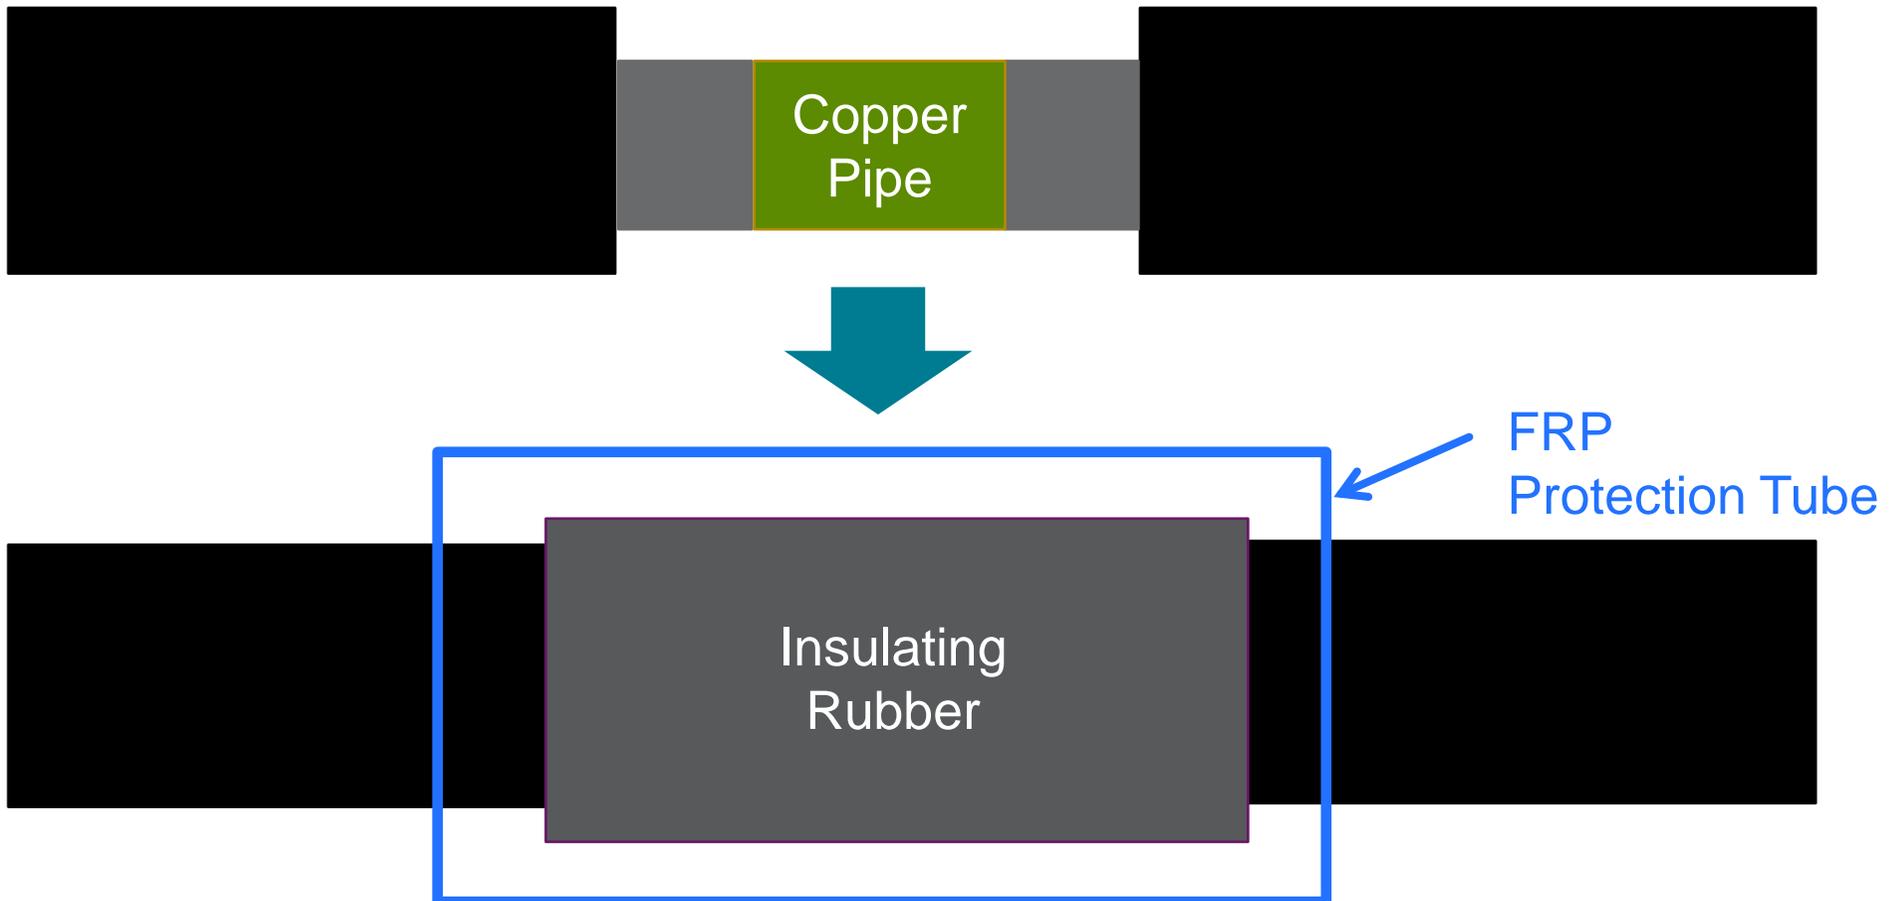
## Case Study 3: Image of a joint (2)

- ◆ The joint tends to be a weak point in the underground electric line as the durability is low compared to other parts.

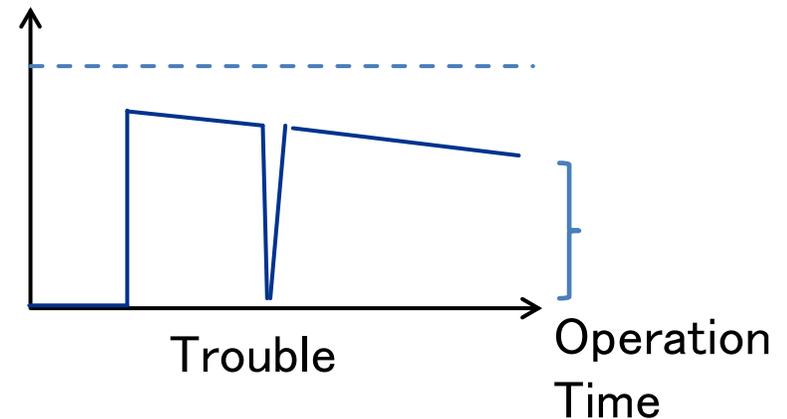
### Case 3 (Capacity)

- ◆ Blackout and disconnection of cables immediately after the start of power distribution
- ◆ Low operation rate
