**KPMG AZSA LLC**

**Case Study:**

**Bad Practices of Electric Power**

**Infrastructure Investment / Development**

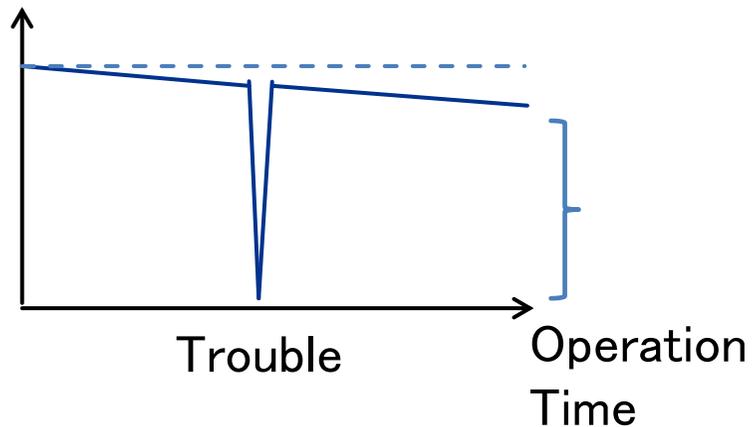
### Ideal Capacity

- ◆ In October 20vv, the flue-gas desulfurization equipment in Unit 1, which was under construction, caught fire from the sparks of welding, leading to a large scale fire. As a result, the construction schedule of Unit 1 was delayed.
- ◆ In 20zz after the operation started, blackouts frequently occurred due to malfunction. The problem was caused by faults in various points such as the relay system of the oil pump motor and the cooling system and steam leakage in the boiler.
- ◆ Steam leakage occurred in December 20ww, but the equipment to identify the location of the fault was not available in Country B, due to its unique feature. Therefore, Company A was required to import this equipment from a foreign country, which took one month. As a result, Company A was forced to halt operation in the long term, leading to significant economic loss.

- ◆ Delay in construction schedule
- ◆ Low operation rate
- ◆ Required significant time to recover from stoppage of operation

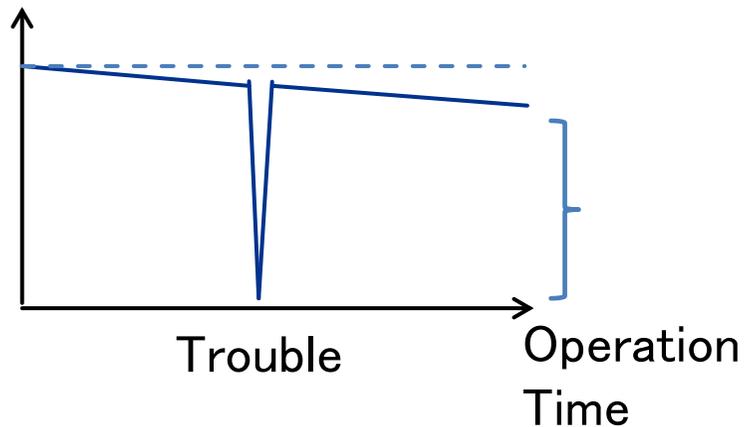
### Ideal Capacity

- ◆ Five large scale blackouts have occurred to date, including the one immediately after the start of power distribution, which caused significant damage to both City K and Company J.

- ◆ The cause of all the blackouts was corruption of the joint.
